1. AGENCY USE ONLY (Leave blank)		2. REPORT DATE 05/00/83		3. REPORT TYPE AND DATES COVERED	
4. TITLE AND SUBTITLE RCRA PART B PERMIT APPLICATION, SELECTED FACILITIES, ROCKY MOUNTAIN ARSENAL, COMMERCE CITY, COLORADO, FINAL REPORT				5. FUNDING NUMBERS

6. AUTHOR(S)					
7. PERFORMING ORGANIZATION NAME(S) AND ADDRESS(ES) D'APPOLONIA CONSULTING ENGINEERS ENGLEWOOD, CO				8. PERFORMING ORGANIZATION REPORT NUMBER 84124R01

13. ABSTRACT (Maximum 200 words) THIS DOCUMENT REPRESENTS RMA'S FORMAL APPLICATION FOR RCRA PART B PERMIT STATUS WITH THE EPA REGION VIII AND WILL REMAIN IN EFFECT UNTIL AMENDED BY RMA LATER IN 1984. THE COMPLETE PART A APPLICATION IS INCLUDED AND WAS REVISED FROM THE ORIGINAL PART A OF NOVEMBER 1980 AND SUBMITTED TO EPA ON JANUARY 28, 1983. MUCH OF THIS APPLICATION WAS PREPARED USING EXISTING DOCUMENTATION AND PROCEDURES AT RMA. IN MANY CASES, INFORMATION WAS EXTRACTED FROM OP'S AND OTHER SOURCES SUCH AS RMA'S DISASTER CONTROL PLAN. SURVEYS WERE CONDUCTED SPECIFICALLY FOR WASTE CONTAINER STORAGE FACILITIES. NEW INFORMATION SUCH AS CLOSURE AND WASTE ANALYSIS PLANS WERE DEVELOPED. TABLES, MAPS AND SUPPORTING REFERENCE MATERIALS ARE INCLUDED. THIS AN INTERIM REPORT. SE

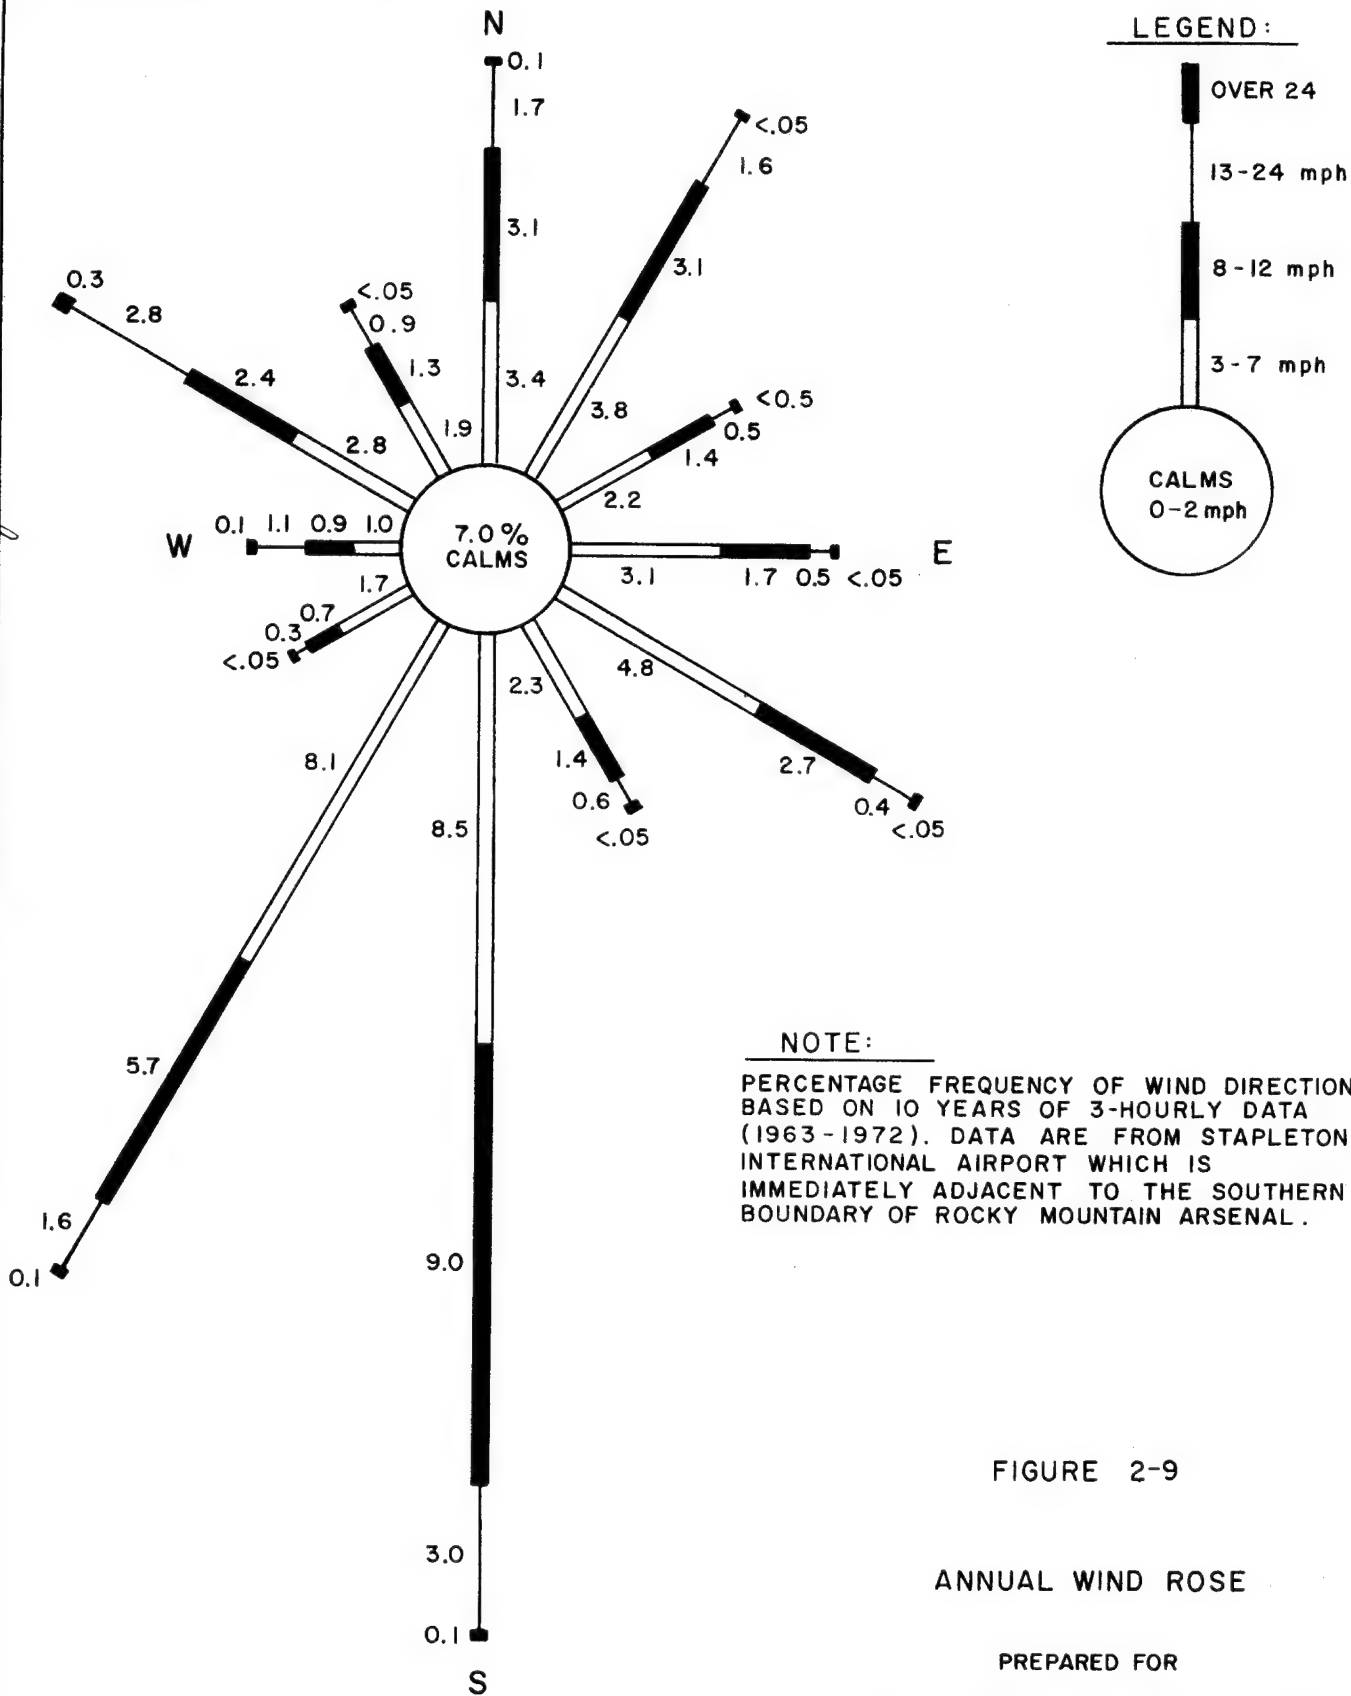
FIGURE 2-9

NOTE:  
PERCENTAGE FREQUENCY OF WIND DIRECTION  
BASED ON 10 YEARS OF 3-HOURLY DATA  
(1963-1972). DATA ARE FROM STAPLETON  
INTERNATIONAL AIRPORT WHICH IS  
IMMEDIATELY ADJACENT TO THE SOUTHERN  
BOUNDARY OF ROCKY MOUNTAIN ARSENAL.

Figure 2-9 presents an annual wind rose showing the occurrences of wind speed and direction for the ten year period 1963 through 1972 at Stapleton International Airport. Stapleton Airport is located adjacent to the southern boundary of Rocky Mountain Arsenal. This monitoring location is operated by the National Weather Service. The data on annual occurrences of wind speed and direction are representative of the conditions at RMA.

A portion of the occurrences from the north through north-northeast are associated with the late morning gradient which forms when the eastern facing mountain slopes warm more rapidly than the flat terrain to the east. This rising air over the mountains causes a pressure void resulting in air movement up the Platte River Valley (from north to south). Also contributing to this north through north-northeast component is the passage of cold air fronts from Canada.

The west-northwest occurrences are typically associated with the tracking of Pacific low pressure across the continent. After the low pressure has passed through the Denver area, the east-southeast component is established. This wind direction often causes an "upslope condition" which results in precipitation to the area.

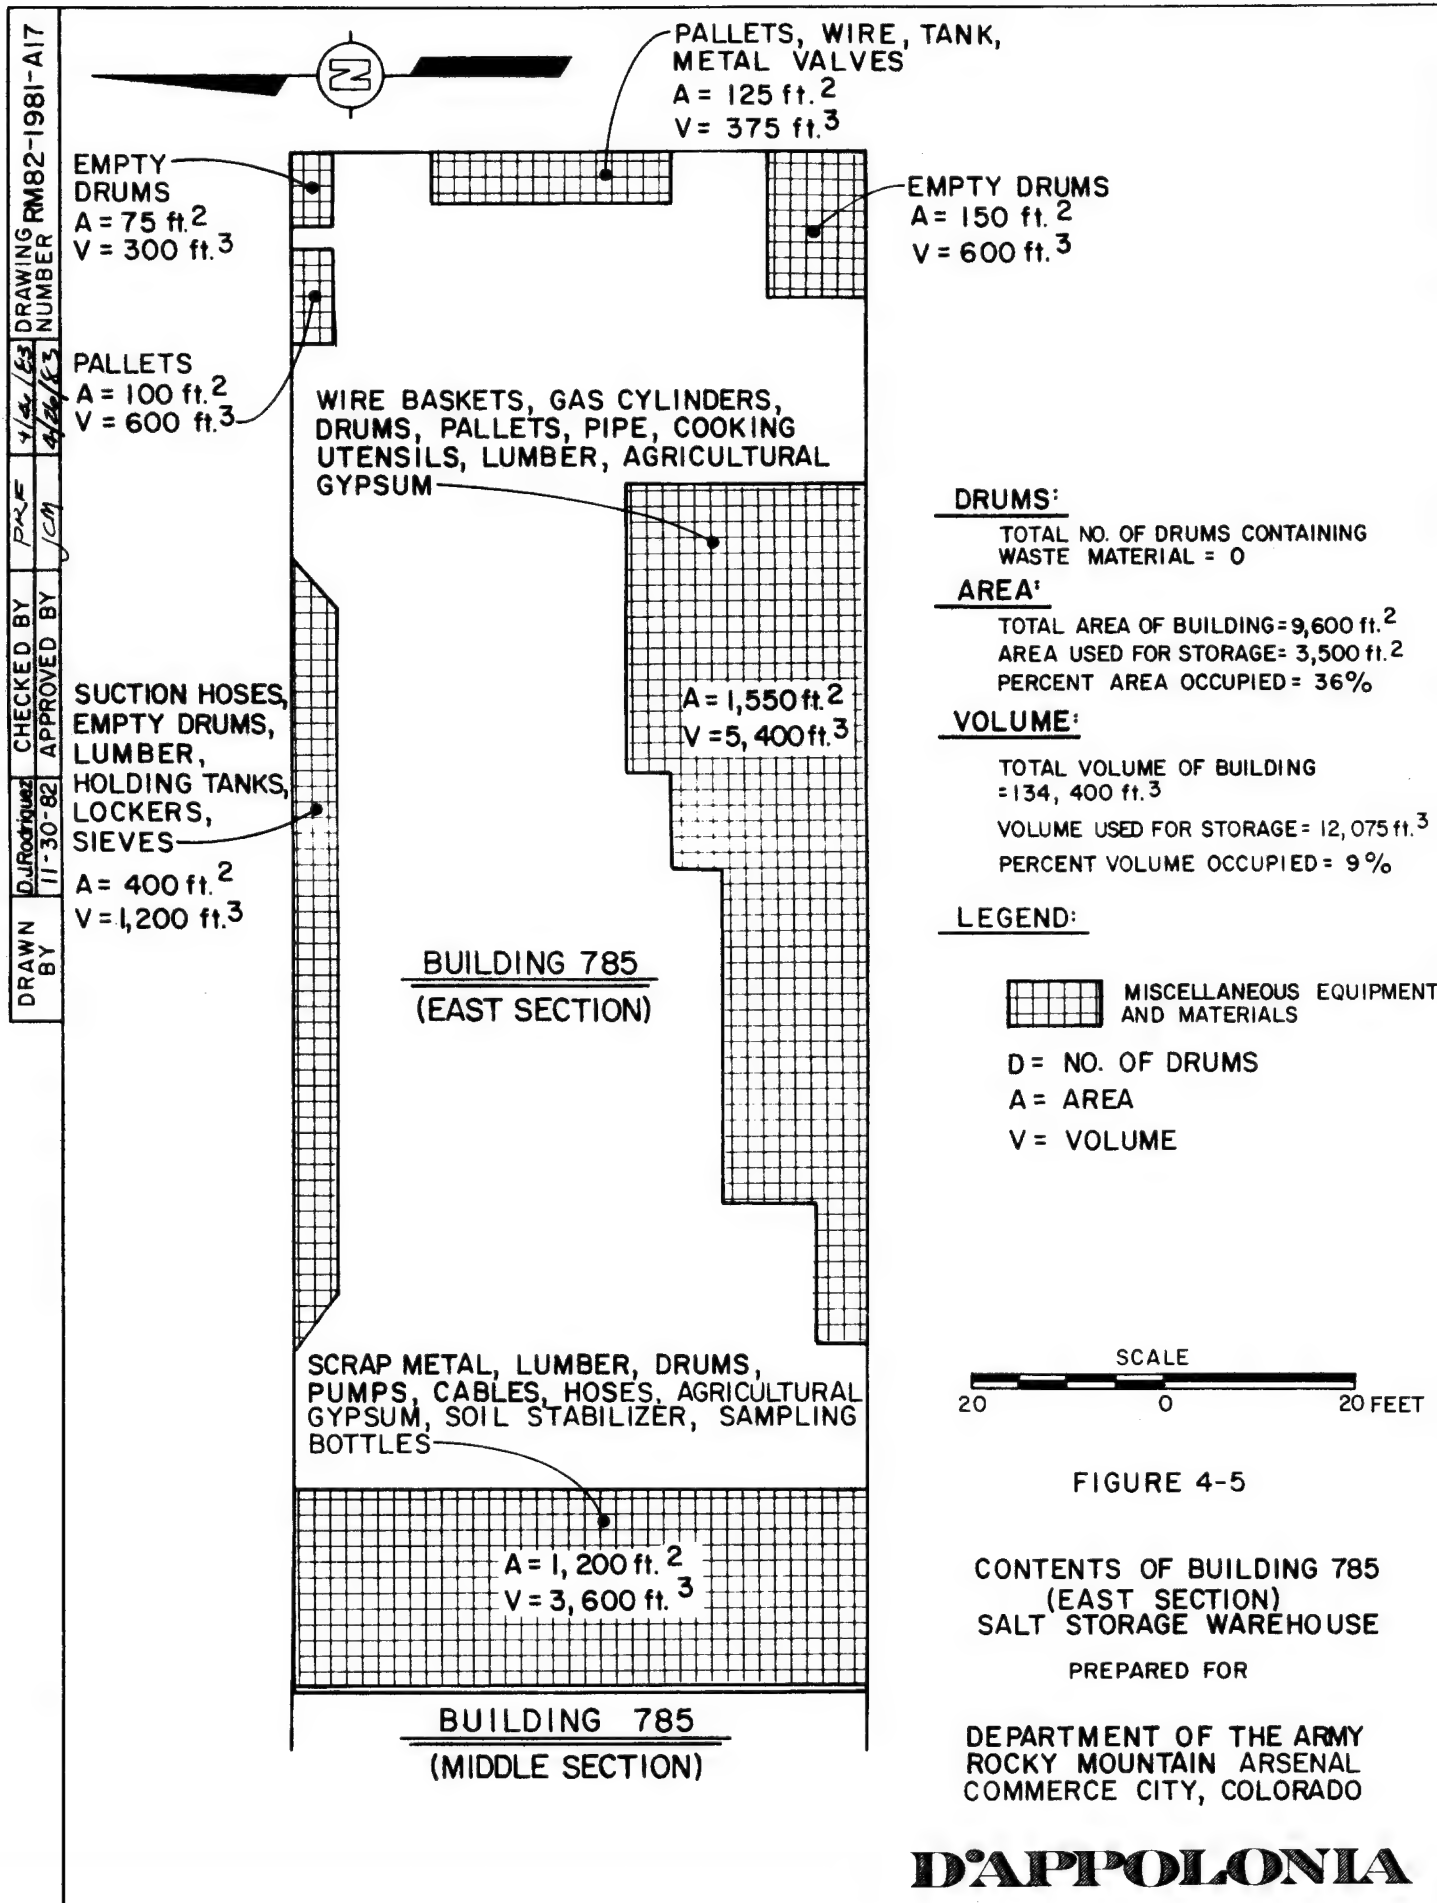
FIGURE 4-5

CONTENTS OF BUILDING 785  
(EAST SECTION)  
SALT STORAGE WAREHOUSE

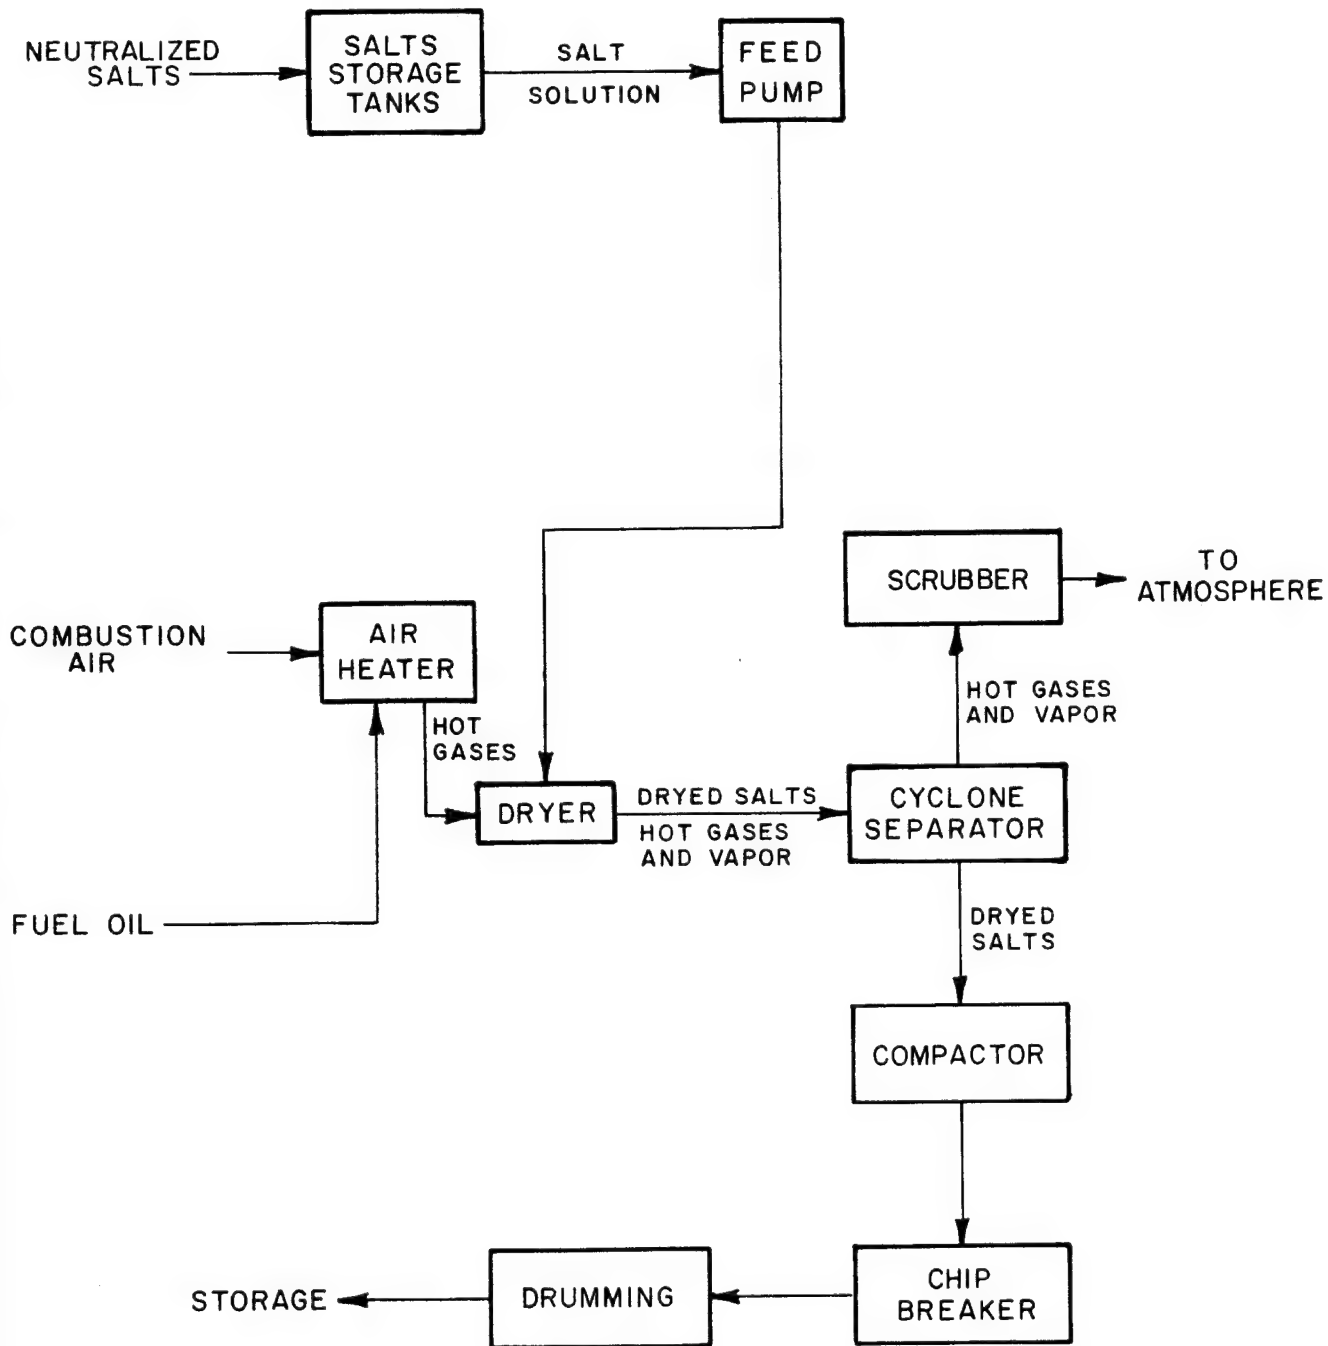
FIGURE 4-22

SALT SOLUTION STORING,  
 DRYING AND DRUMMING  
 BLOCK DIAGRAM

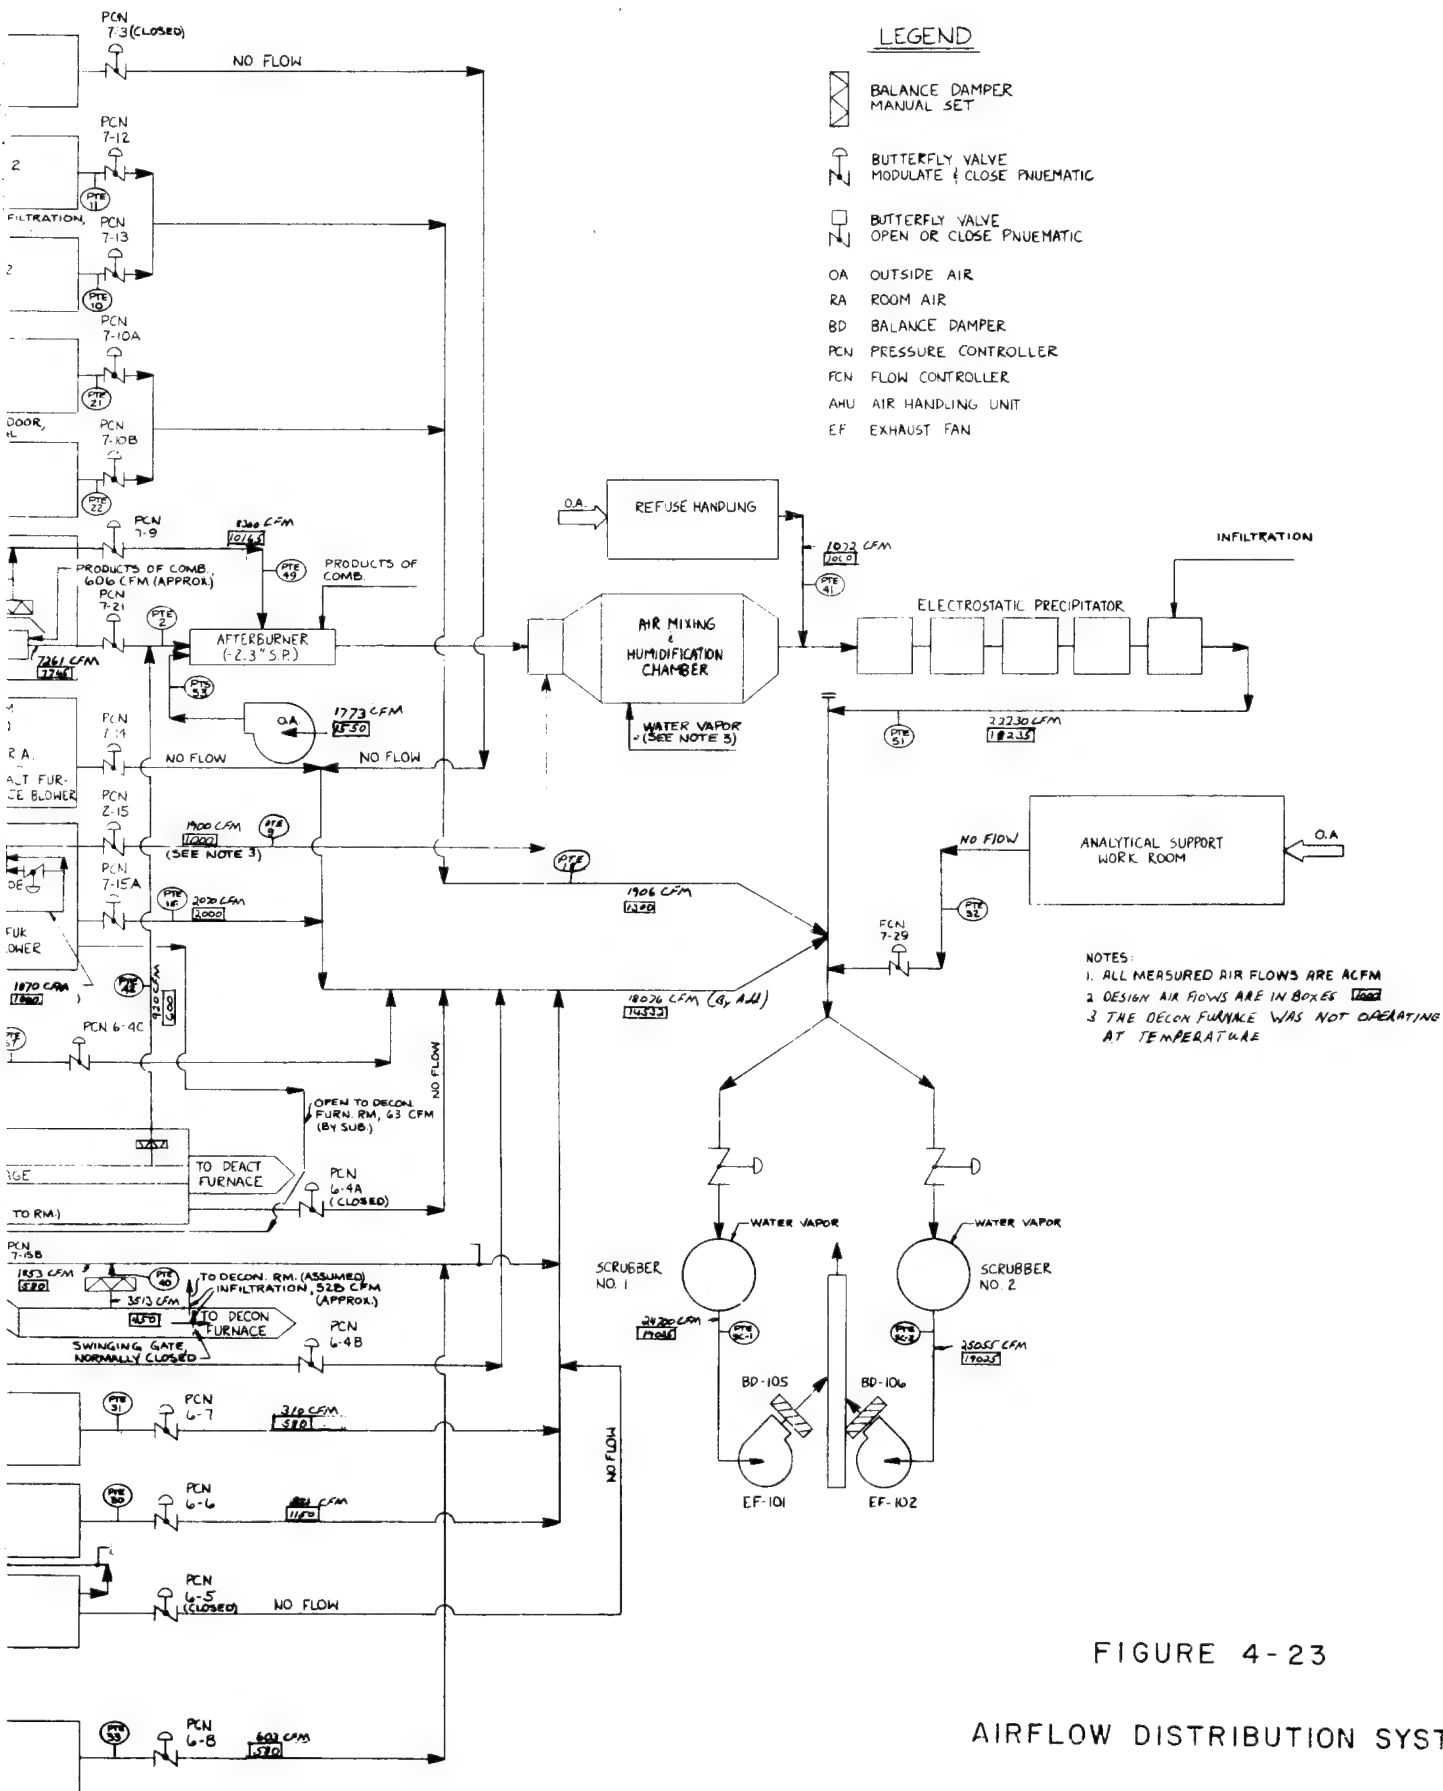
FIGURE 4-23

AIRFLOW DISTRIBUTION SYSTEM

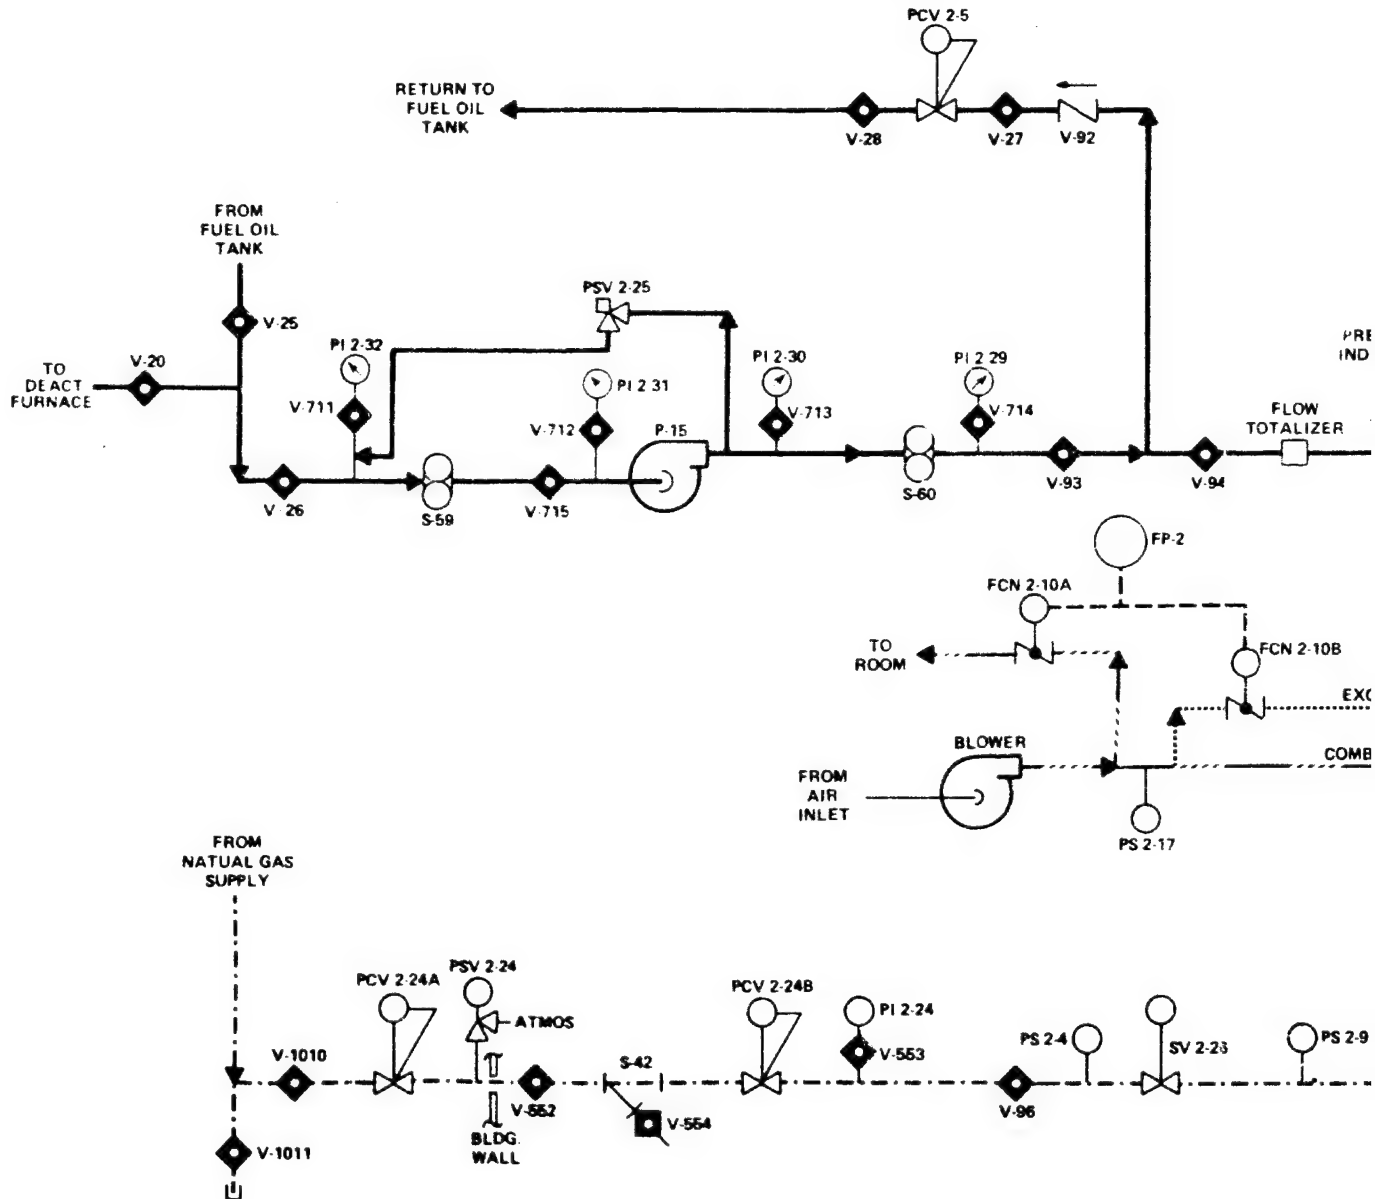
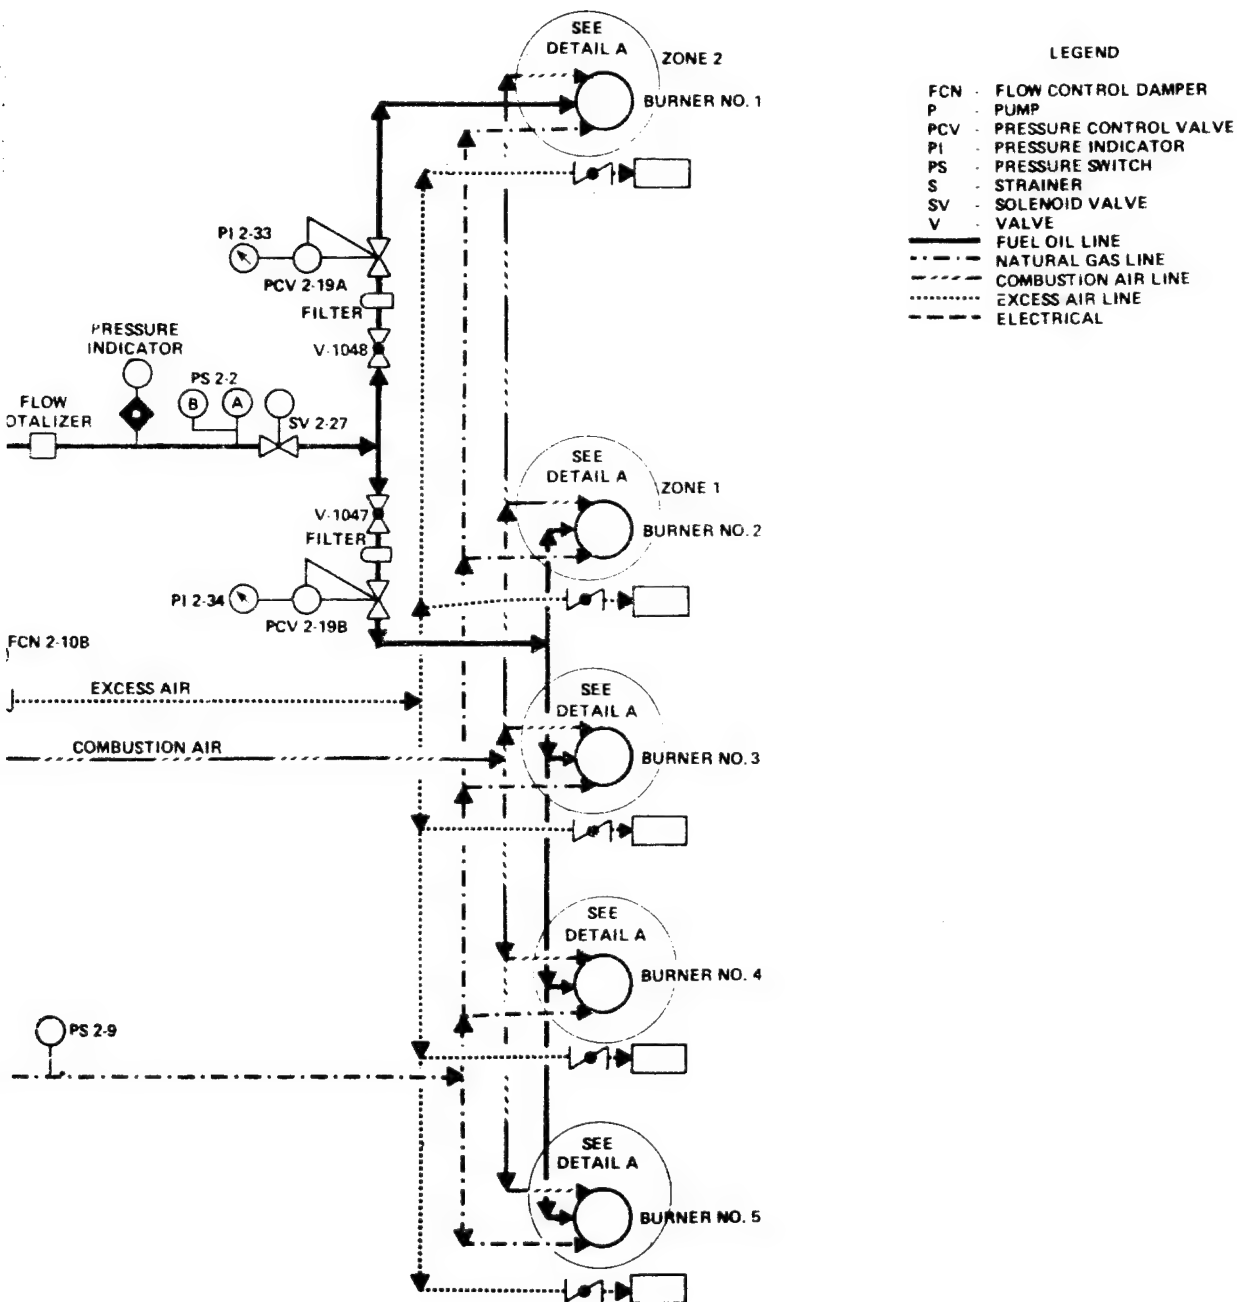
BURNER COMPONENT REFERENCE DESIGNATORS

SCHEMATIC OF PRESSURE  
AND FLOW MONITORING DEVICES  
FOR DECONTAMINATION FURNACE

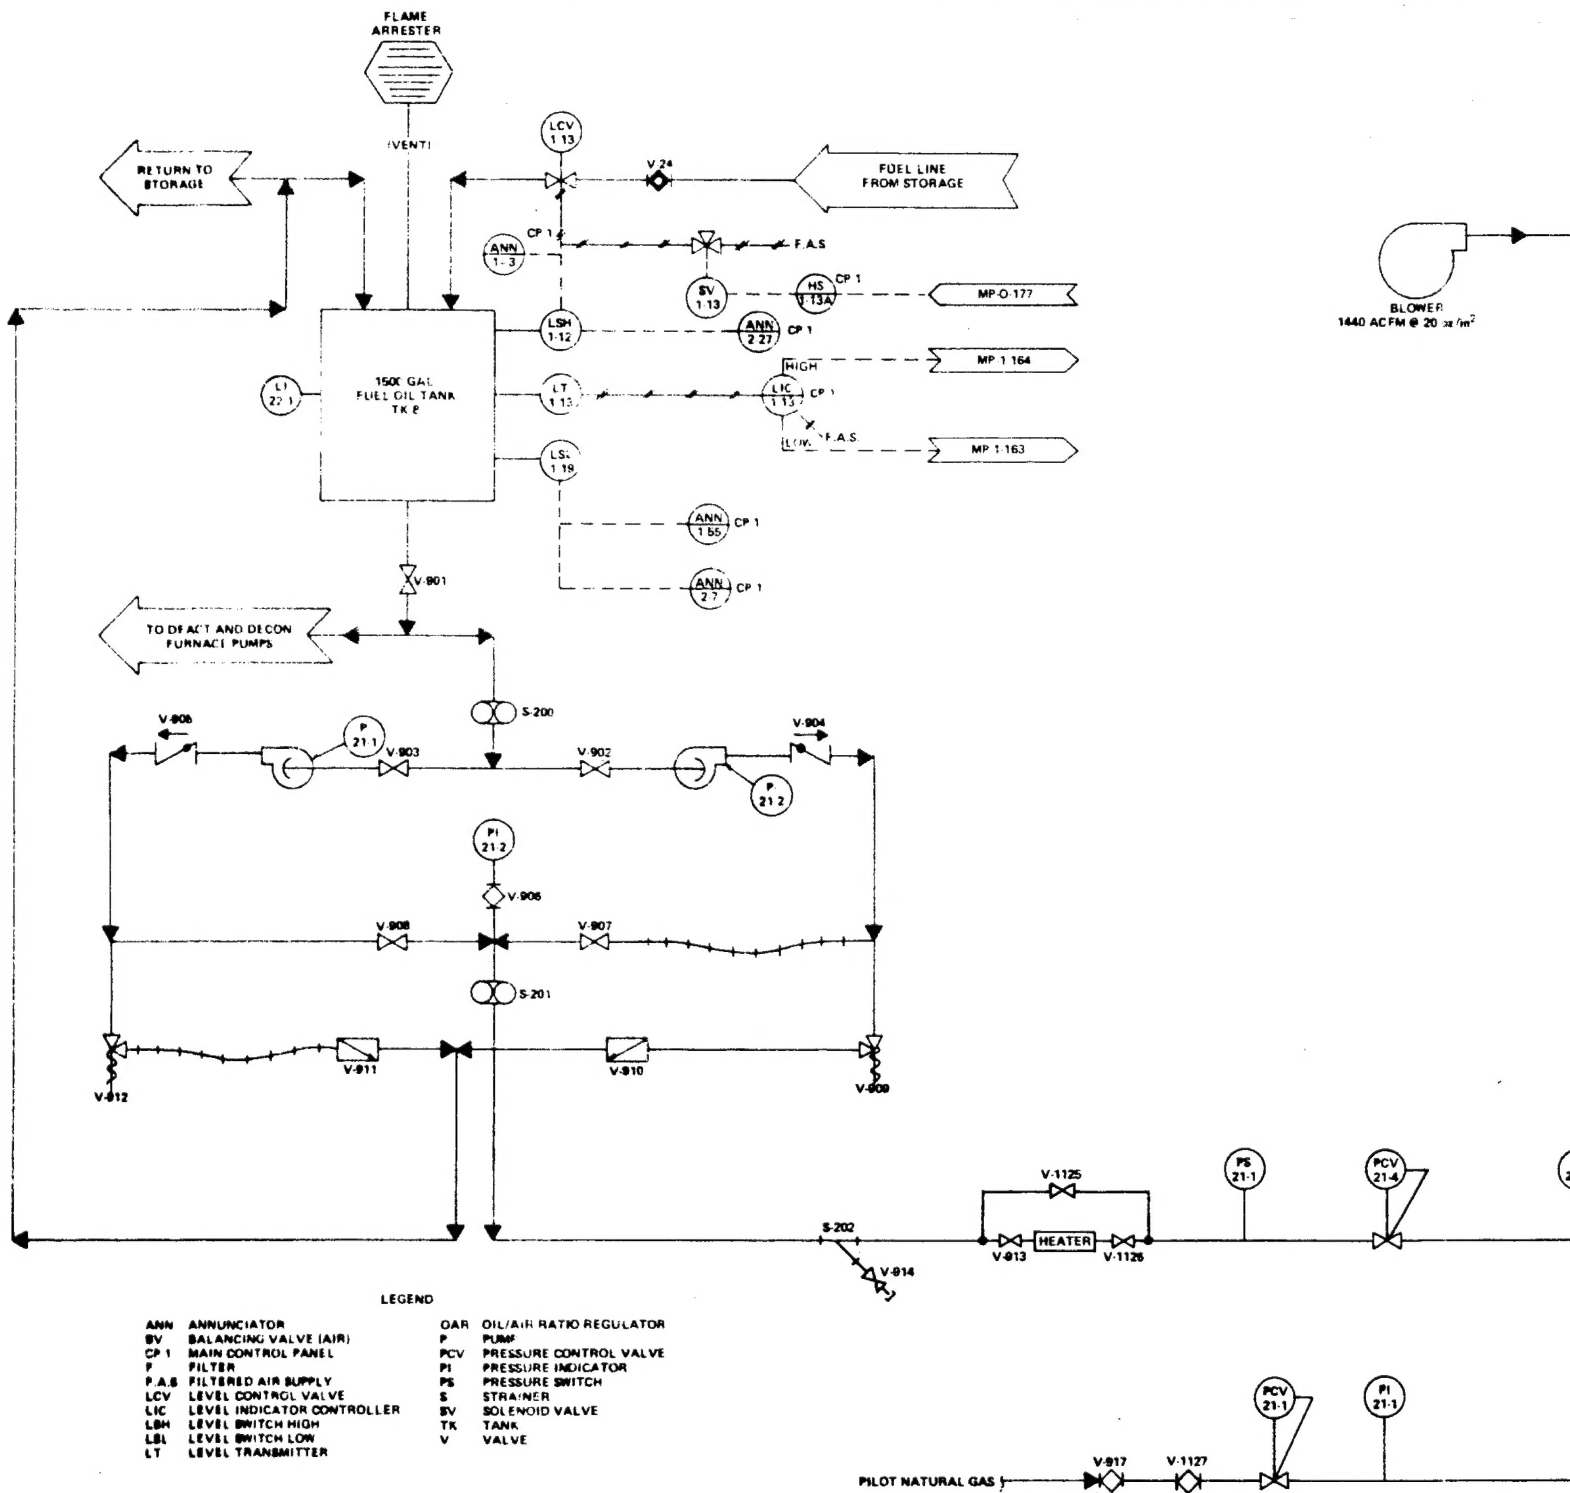
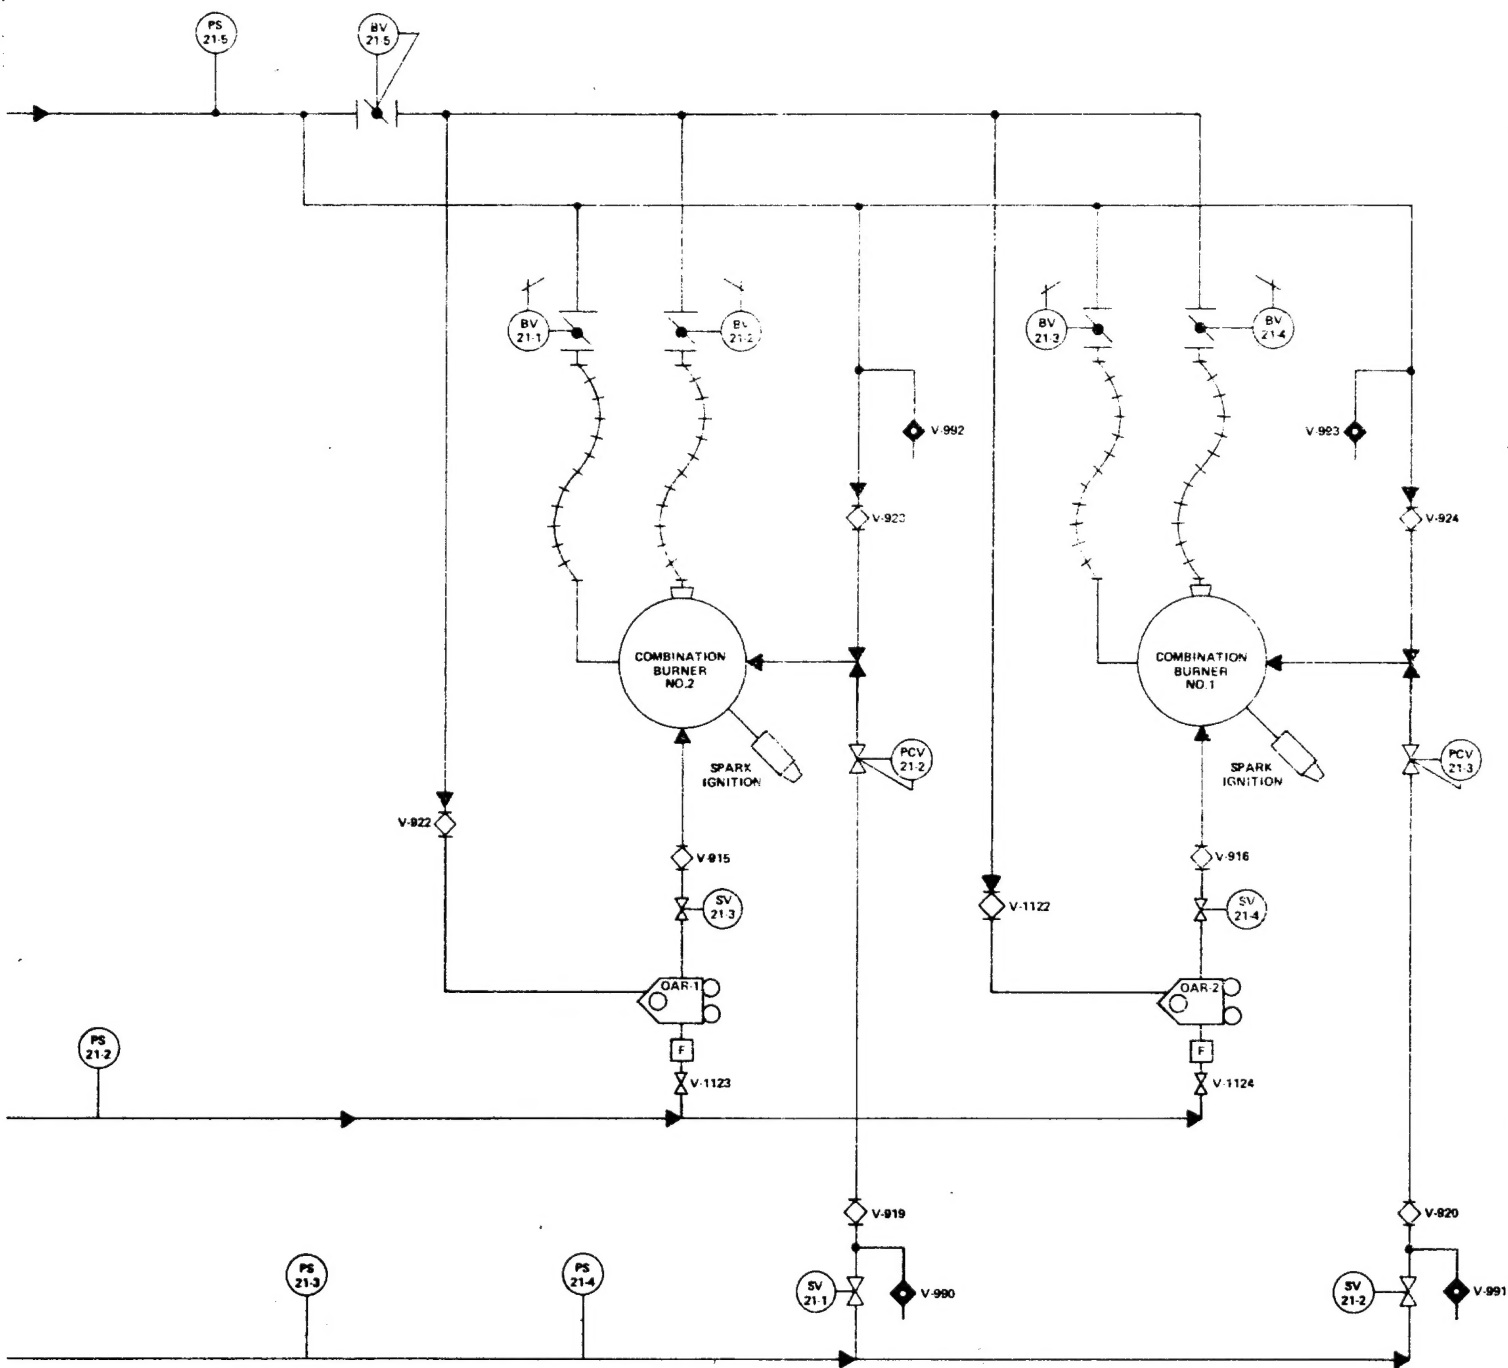
FIGURE 4-26

SCHEMATIC OF PRESSURE  
AND FLOW MONITORING DEVICES  
FOR AFTERBURNER
